CASE STUDY

Throsby Creek, Newcastle

LIGHTING COMPLIANCE

A win for wildlife and the community with SMART solar lights along Throsby Creek in Newcastle

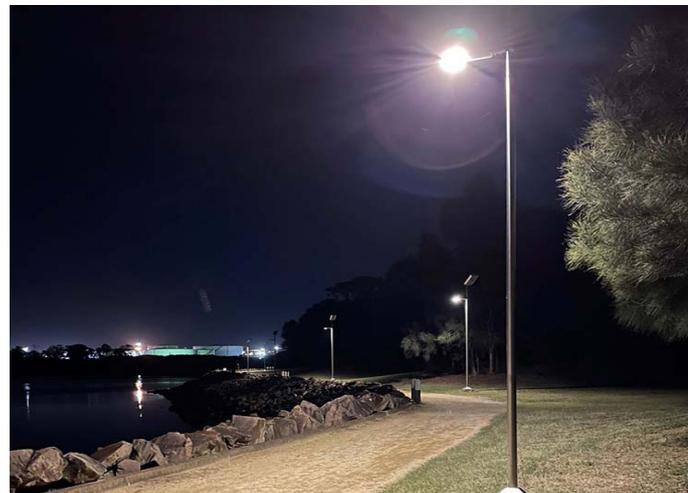
They invited Leadsun to design the solution, which included EZYfoot concrete-less, footings using stainless steel micro-piles that would not corrode nor release further contaminants into the soil.

Under the conditions of the grant funding, the lighting solution needed to be delivered within six months. However, given the easy installation afforded by the innovative design of Leadsun lights – which require no trenching, use concrete-less footings and are easily raised by two people with the help of EZYtilt poles – Leadsun was able to take the project from procurement to installation within 8 weeks.

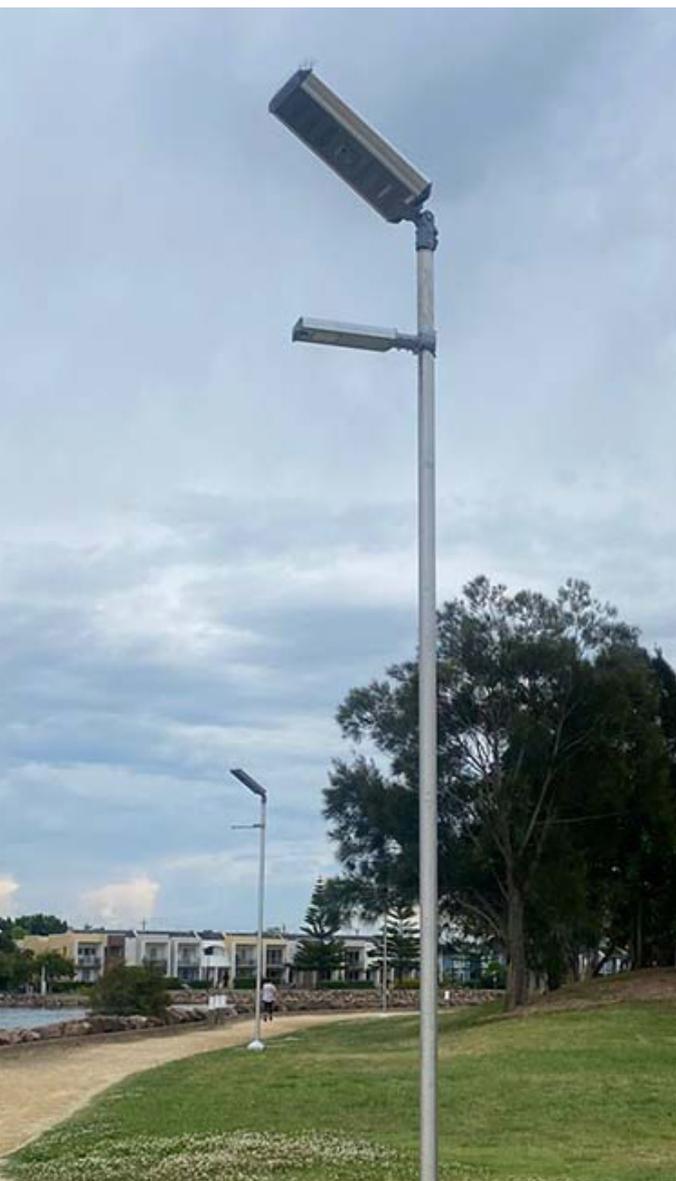
Leadsun System

- AE3 solar lights
- EZYfoot EF250 stainless steel foundations
- LED output 10W
- 308 lithium-ion batteries
